29-609

Vauxhall steering wheel control interface

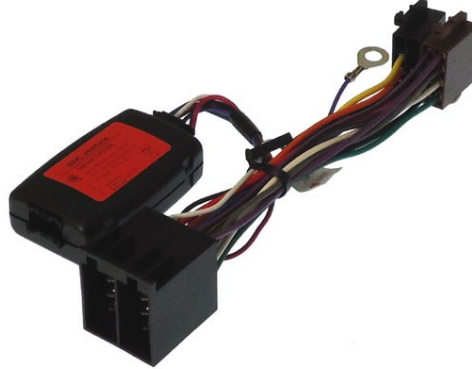
Volume up
Volume down
Seek/track up
Seek/track down
Source
Band

Connect the head unit specific patch lead to the interface first. If using a universal patch lead, check it is setup correctly. Refer to the diagrams overleaf to check the patch lead is correct.

Connect the ISO connectors and patch lead to the new head unit.

Connect the purple wire with the ring terminal to a chassis ground.

Connect the 29-609 harness to the vehicle harness.

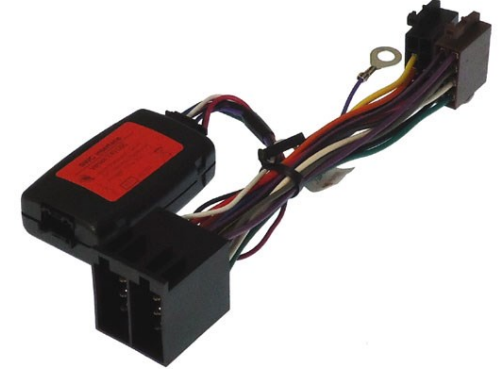
Vauxhall steering wheel control interface

Volume up
Volume down
Seek/track up
Seek/track down
Source
Band

Connect the head unit specific patch lead to the interface first. If using a universal patch lead, check it is setup correctly. Refer to the diagrams overleaf to check the patch lead is correct.

Connect the ISO connectors and patch lead to the new head unit.

Connect the purple wire with the ring terminal to a chassis ground.

Connect the 29-609 harness to the vehicle harness.

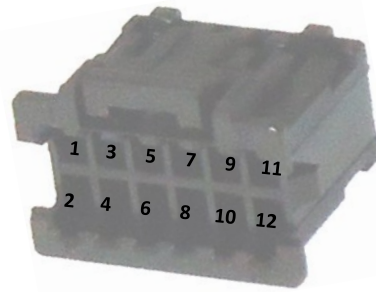
29-000 Self learning units
Single wires pins 1 and 2
No loops

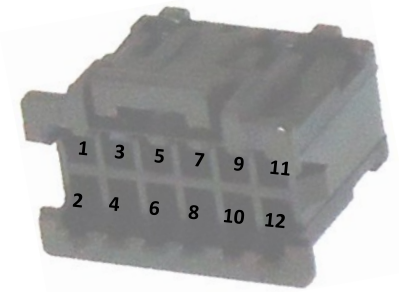
29-000 Self learning units
Single wires pins 1 and 2
No loops
